**Flood Control Project Maintenance
Levee Inspections**
LMA District Cover Sheet
Spring 2017 Levee Inspection Results

Sacramento Maintenance Yard West Levee Yolo Bypass

Levee Inspection Report By Mile - Spring 2017

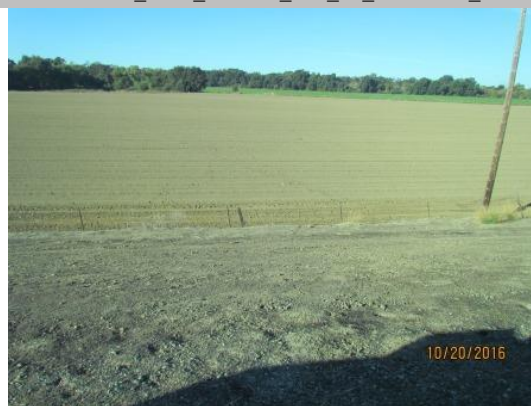
Photo 1 of 2 : SP_2017_ST0011_291_10_20170320_00006.jpg

View of fence located within 10-foot easement of landside toe. Fall 2016.

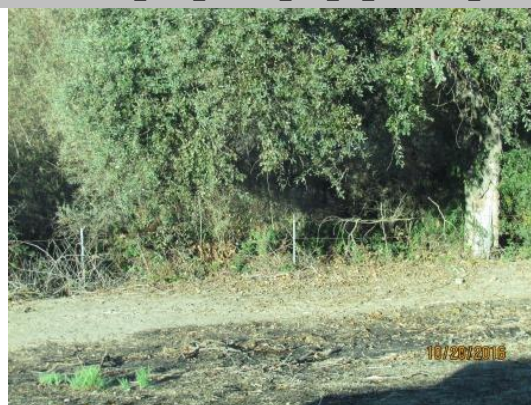
Photo 2 of 2 : SP_2017_ST0011_291_10_20170320_00007.jpg

Another view of fence located within 10-foot easement of landside toe. Fall 2016.

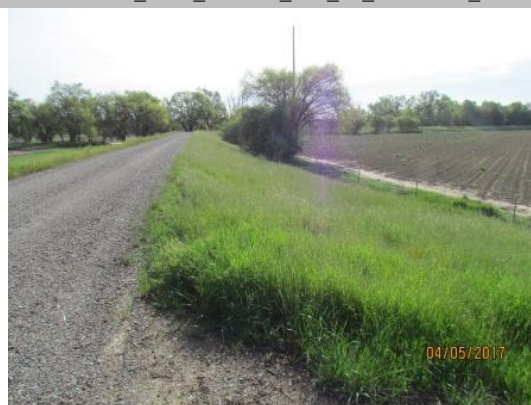
Photo 1 of 1 : SP_2017_ST0011_291_14_20170413_00021.jpg

LM Start	0.00	Rating **	U	Issue No.	14
LM End	2.72	Issue Type +	Ma	Location *	LS
Category	Earthen Levee			GPS Latitude/Longitude	
				Start	End
Item	Vegetation			38.758935 °	38.724274 °
				-121.667521 °	-121.665112 °
DWR ID	DWR_ST0011_01_s_2017_14				
Comment Code					
V1 : Control annual grass and weeds on the levee slopes and easements.					
Inspector Comment

Tall grass on landside levee slope, blocking visibility. Spring 2017.

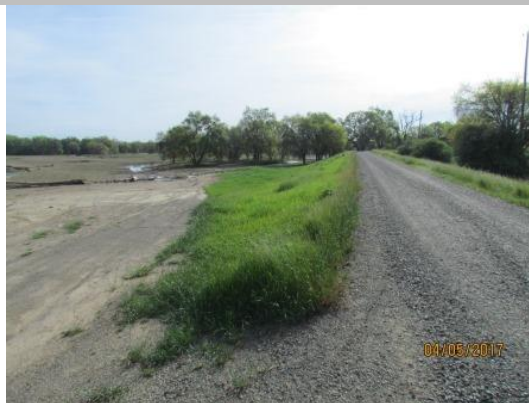
Photo 1 of 1 : SP_2017_ST0011_291_13_20170413_00020.jpg

Tall grass on waterside levee slope, blocking visibility. Spring 2017.

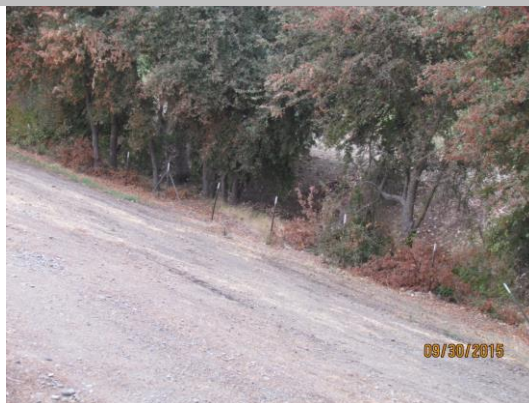
Photo 1 of 1 : SP_2017_ST0011_291_8_20170320_00003.jpg

LM Start	0.94	Rating **	M	Issue No.	8
LM End	1.83	Issue Type +	En	Location *	LS
Category	Earthen Levee			GPS Latitude/Longitude	
				Start	End
Item	Encroachments			38.747888 °	38.734972 °
				-121.660202 °	-121.660265 °
DWR ID	DWR_ST0011_01_s_2012_8				
Comment Code					
DT : Ditch					
Inspector Comment					
The ditch is at the toe of the levee.

View of the ditch on the landward side of the levee. Fall 2015.

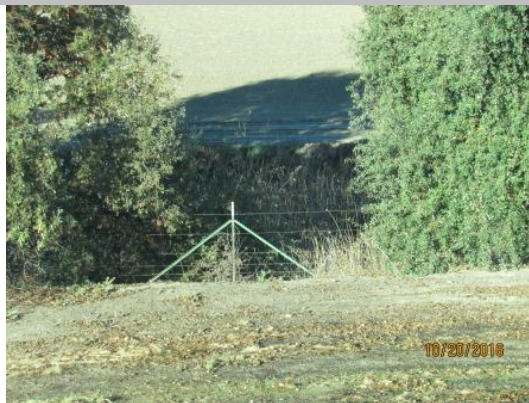
Photo 1 of 2 : SP_2017_ST0011_291_9_20170320_00004.jpg

LM Start	1.70	Rating **	M	Issue No.	9
LM End	1.79	Issue Type +	En	Location *	LS
Category	Earthen Levee			GPS Latitude/Longitude	
				Start	End
Item	Encroachments			38.736842 °	38.735498 °
				-121.660285 °	-121.660287 °
DWR ID	DWR_ST0011_01_f_2016_9				
Comment Code					
FE : Fence					
Inspector Comment

View of fence along the ditch on landside. Fall 2016.

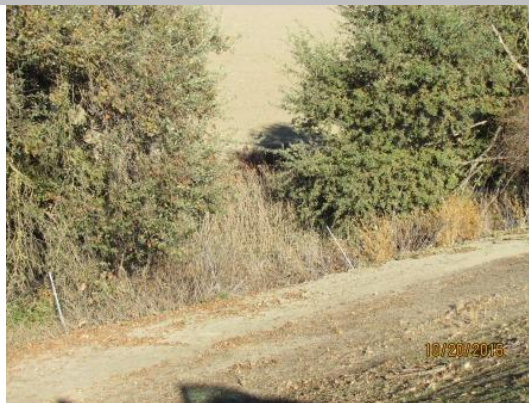
Photo 2 of 2 : SP_2017_ST0011_291_9_20170320_00005.jpg

Another view of fence along the ditch on landside. Fall 2016.

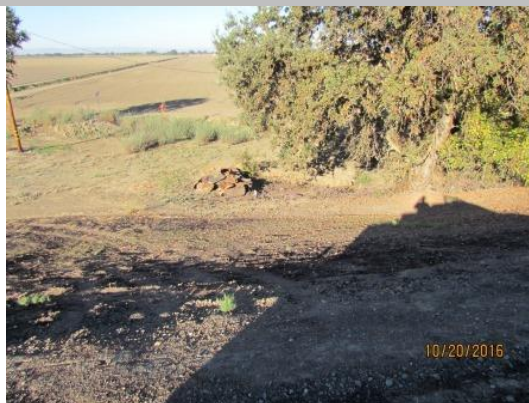
Photo 1 of 1 : SP_2017_ST0011_291_3_20170320_00001.jpg

LM Start	1.83	Rating **	M	Issue No.	3
LM End	1.83	Issue Type +	En	Location *	LS
Category	Earthen Levee			GPS Latitude/Longitude	
				Start	End
Item	Encroachments			38.734936 °	38.734936 °
				-121.660281 °	-121.660281 °
DWR ID	DWR_ST0011_01_f_2016_3				
Comment Code					
GA : Garbage					
Inspector Comment

View of garbage within 10-foot easement of LS levee toe. Fall 2016.

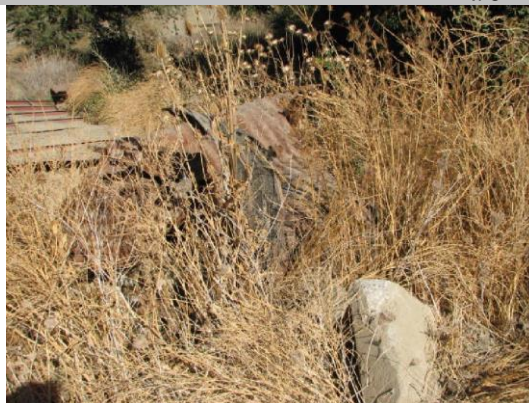
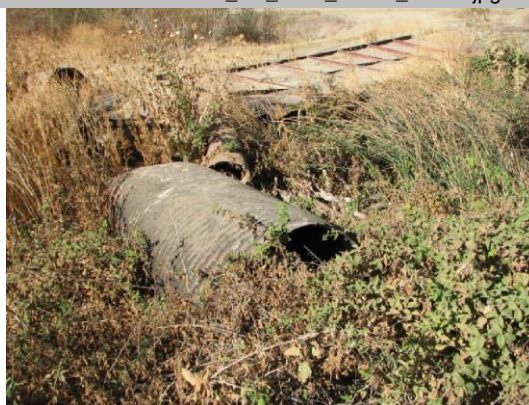
LM Start	1.85	Rating **	M	Issue No.	17
LM End	1.85	Issue Type +	En	Location *	LS
Category	Supplemental			GPS Latitude/Longitude	
				Start	End
Item	DWR UCIP Field Study			38.734568 °	38.734568 °
				-121.660264 °	-121.660264 °
DWR ID					
Comment Code					
Inspector Comment					
FS_ID:50785					
DS_ID:17744					
EP_NO: 10284					
Repair Type: Non-Urgent					
Crossing Status: Indicator Found					
UCIP Comments: Found abandoned 42-inch CM pipe on LS berm of the levee. This was abandoned by farmer, how Unknown. need to have verified if removed or concreted					
FIELD_STRUCT_DESC: 42-inch CM drainpipe through levee 25.0 feet below crown. Slide gate on waterward end. (ABO No. 10284 - Hershey).					
O&M manual 127, Revision Year 2011					
FS Date: 11/18/2016 2:55:55 PM

Landside view: an abandoned CM pipe on LS berm of the levee.

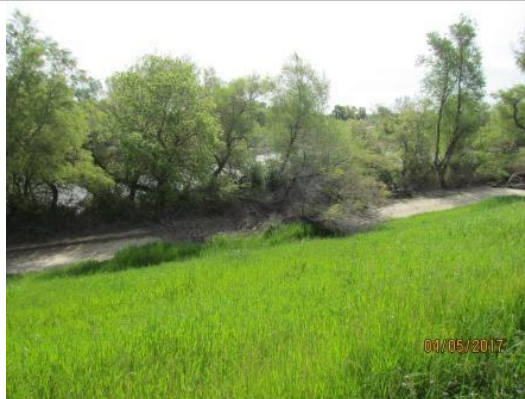
Photo 1 of 1 : SP_2017_ST0011_291_15_20170413_00022.jpg

View of fallen tree at waterside levee toe, looking downstream. Spring 2017.

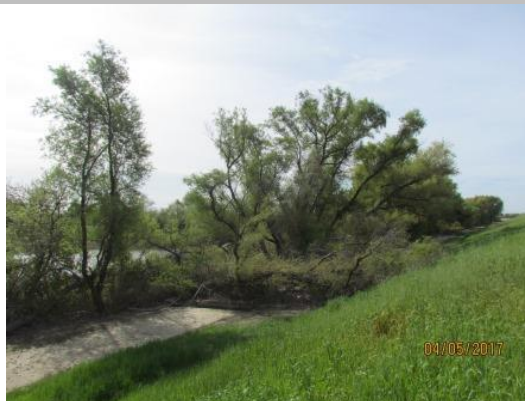
Photo 1 of 1 : SP_2017_ST0011_291_16_20170413_00023.jpg

LM Start	2.20	Rating **	M	Issue No.	16
LM End	2.20	Issue Type +	Ma	Location *	WS
Category	Earthen Levee			GPS Latitude/Longitude	
				Start	End
Item	Encroachments			38.729588 °	38.729588 °
				-121.660263 °	-121.660263 °
DWR ID	DWR_ST0011_01_s_2017_16				
Comment Code					
TR : Tree or limb					
Inspector Comment					
Fallen tree on waterside levee toe and slope.

View of fallen tree on waterside levee slope, looking downstream. Spring 2017.

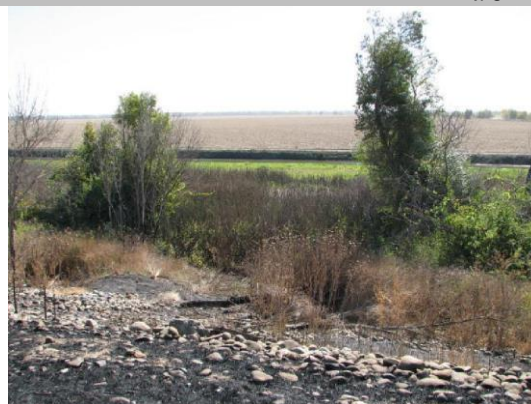
Photo 1 of 3 : UCIP_SP_2017_50787_60304.jpg

LM Start	2.63	Rating **	A/W	Issue No.	18
LM End	2.63	Issue Type +	Ma	Location *	LS
Category	Supplemental			GPS Latitude/Longitude	
				Start	End
Item	DWR UCIP LMA Responsibility			38.724824 °	38.724824 °
				-121.663702 °	-121.663702 °
DWR ID					
Comment Code					
Inspector Comment					
FS_ID:50787					
DS_ID:17742					
EP_NO: 10284					
Repair Type: No Action Needed					
Crossing Status: Found					
UCIP Comments: Screw gates where removed and pipe was abanded by farmer, How pipe was abanded is unknown.					
FIELD_STRUCT_DESC: One of two pipes.Two 42-inch CM drainpipes through levee 23.6 feet below crown. Concrete spill box at toe of landward slope. (ABO No. 10284 - Hershey).					
O&M manual 127, Revision Year 2011					
FS Date: 11/18/2016 2:57:05 PM

Waterside view: overview (pipe not found)

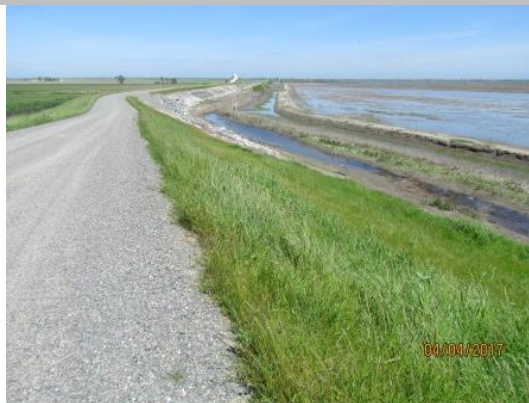
Photo 1 of 1 : SP_2017_ST0011_292_4_20170413_00011.jpg

Tall grass on waterside levee slope, blocking visibility. Spring 2017.

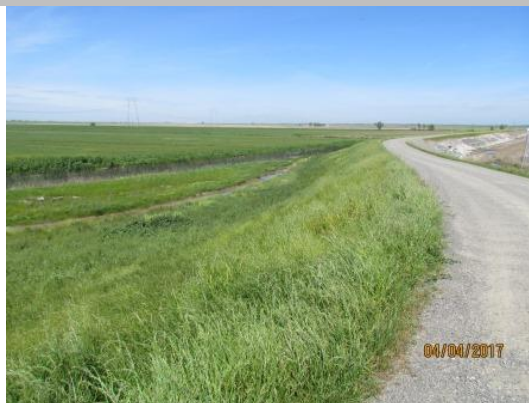
Photo 1 of 1 : SP_2017_ST0011_292_2_20170413_00010.jpg

LM Start	0.01	Rating **	U	Issue No.	2
LM End	1.51	Issue Type +	Ma	Location *	LS
Category	Earthen Levee			GPS Latitude/Longitude	
				Start	End
Item	Vegetation			38.718969 °	38.698683 °
				-121.664111 °	-121.674135 °
DWR ID	DWR_ST0011_02_s_2017_2				
Comment Code					
V1 : Control annual grass and weeds on the levee slopes and easements.					
Inspector Comment

Tall grass on landside levee slope, blocking visibility. Spring 2017.

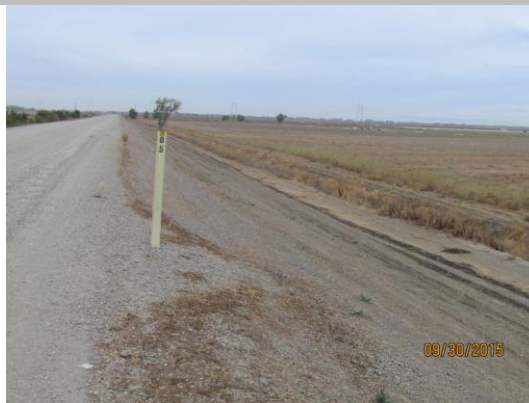
Photo 1 of 3 : SP_2017_ST0011_292_3_20170320_00001.jpg

LM Start	0.47	Rating **	M	Issue No.	3
LM End	0.97	Issue Type +	En	Location *	LS
Category	Earthen Levee			GPS Latitude/Longitude	
				Start	End
Item	Encroachments			38.712813 °	38.706018 °
				-121.667349 °	-121.670831 °
DWR ID	DWR_ST0011_02_s_2012_3				
Comment Code					
DT : Ditch					
Inspector Comment					
Ditch was deepened to approximately 10 ft.

View of the ditch at the landward side of the levee looking downstream.
Fall 2015.

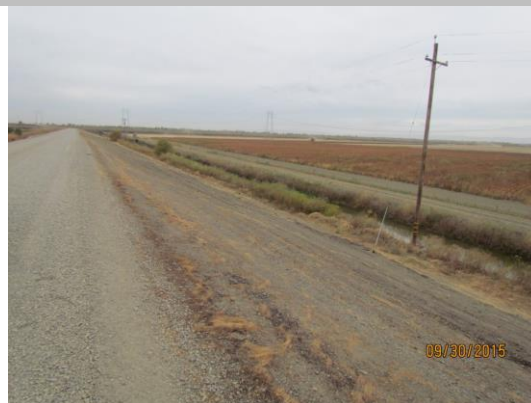
Photo 1 of 1 : SP_2017_ST0011_292_5_20170320_00004.jpg

LM Start	1.15	Rating **	M	Issue No.	5
LM End	1.44	Issue Type +	En	Location *	LS
Category	Earthen Levee			GPS Latitude/Longitude	
				Start	End
Item	Encroachments			38.703681 °	38.699637 °
				-121.672090 °	-121.674112 °
DWR ID	DWR_ST0011_02_s_2012_5				
Comment Code					
DT : Ditch					
Inspector Comment					
The ditch is at the toe of the levee.

View of the ditch on the landward side of the levee looking downstream. Fall 2015.

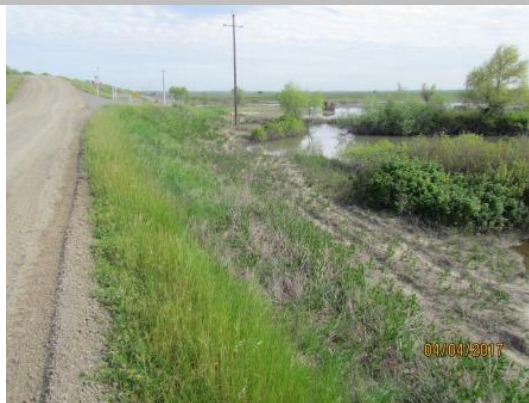
Photo 1 of 1 : SP_2017_ST0011_293_5_20170413_00008.jpg

Tall grass on waterside levee slope, blocking visibility. Spring 2017.

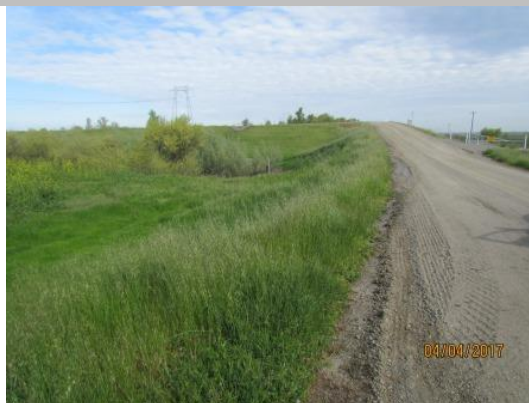
Photo 1 of 1 : SP_2017_ST0011_293_4_20170413_00007.jpg

LM Start	0.01	Rating **	U	Issue No.	4
LM End	0.76	Issue Type +	Ma	Location *	LS
Category	Earthen Levee			GPS Latitude/Longitude	
				Start	End
Item	Vegetation			38.698496°	38.687575°
				-121.674129°	-121.673738°
DWR ID	DWR_ST0011_03_s_2017_4				
Comment Code					
V1 : Control annual grass and weeds on the levee slopes and easements.					
Inspector Comment

Tall grass on landside levee slope, blocking visibility. Spring 2017.

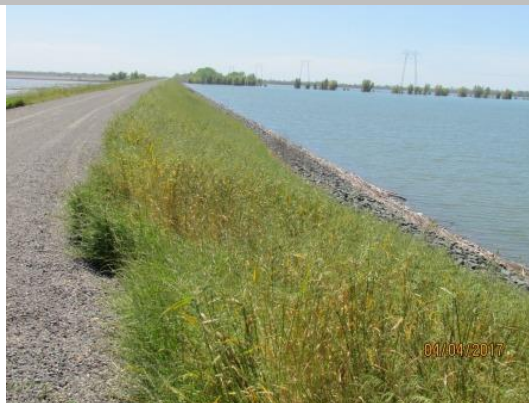
Photo 1 of 1 : SP_2017_ST0011_293_2_20170413_00010.jpg

Tall grass on landside levee slope, blocking visibility. Spring 2017.

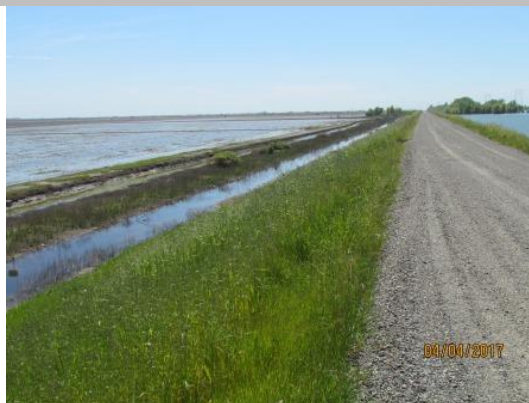
Photo 1 of 1 : SP_2017_ST0011_293_3_20170413_00009.jpg

Tall grass on waterside levee slope, blocking visibility. Spring 2017.

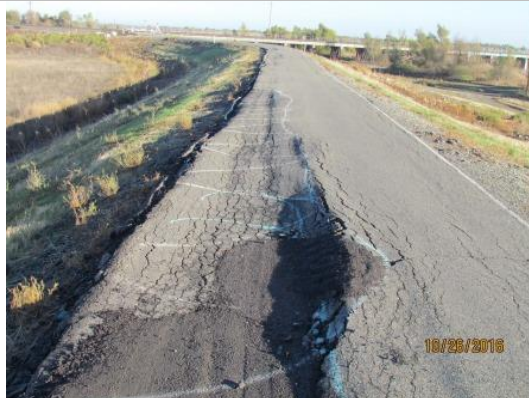
Photo 1 of 1 : SP_2017_ST0011_294_12_20170320_00008.jpg

LM Start	0.68	Rating **	M	Issue No.	12
LM End	0.69	Issue Type +	Ma	Location *	CR
Category	Earthen Levee			GPS Latitude/Longitude	
				Start	End
Item	Crown Surface / Depressions / Rutting			38.564543 °	38.564403 °
				-121.638355 °	-121.638359 °
DWR ID	DWR_ST0011_04_f_2016_12				
Comment Code					
C2 : Repair depressions or ruts in the crown or slope.					
Inspector Comment

Asphalt paved crown has depression at this site. Fall 2016.

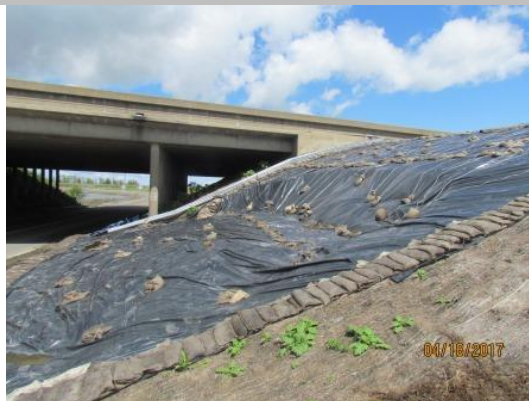
Photo 1 of 1 : SP_2017_ST0011_294_30_20170419_00022.jpg

LM Start	0.77	Rating **	U	Issue No.	30
LM End	0.77	Issue Type +	Ma	Location *	LS
Category	Earthen Levee			GPS Latitude/Longitude	
				Start	End
Item	Erosion / Bank Caving			38.563251 °	38.563251 °
				-121.638299 °	-121.638299 °
DWR ID	DWR_ST0011_04_s_ 2017_30				
Comment Code					
E2 : Schedule repair of erosion site prior to the next inspection.					
Inspector Comment					
Large sloughing section on landside levee slope.

View of sloughing on landside levee slope. Spring 2017.

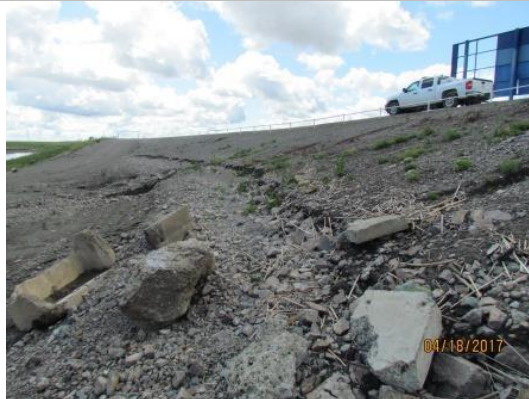
Photo 1 of 2 : SP_2017_ST0011_294_32_20170419_00023.jpg

LM Start	0.78	Rating **	M	Issue No.	32
LM End	0.80	Issue Type +	Ma	Location *	WS
Category	Earthen Levee			GPS Latitude/Longitude	
				Start	End
Item	Erosion / Bank Caving			38.563181 °	38.562769 °
				-121.638306 °	-121.638309 °
DWR ID	DWR_ST0011_04_s_2017_32				
Comment Code					
E2 : Schedule repair of erosion site prior to the next inspection.					
Inspector Comment					
Section of wave wash erosion on waterside levee slope.

View of wave wash erosion on waterside levee slope. Spring 2017.

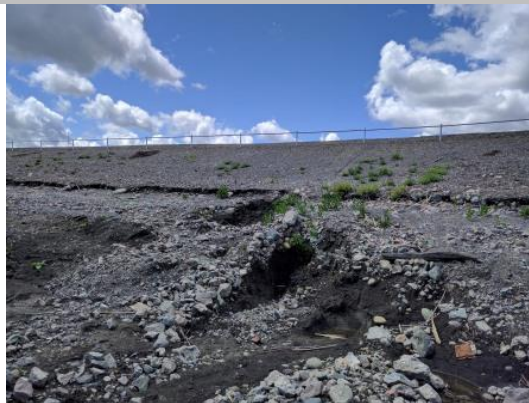
Photo 2 of 2 : SP_2017_ST0011_294_32_20170419_00024.jpg

Additional view of erosion on waterside levee slope. Spring 2017.

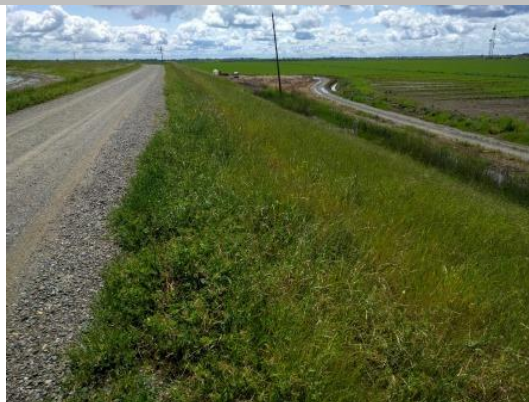
Photo 1 of 1 : SP_2017_ST0011_294_31_20170419_00026.jpg

Tall grass on landside levee slope, blocking visibility. Spring 2017.

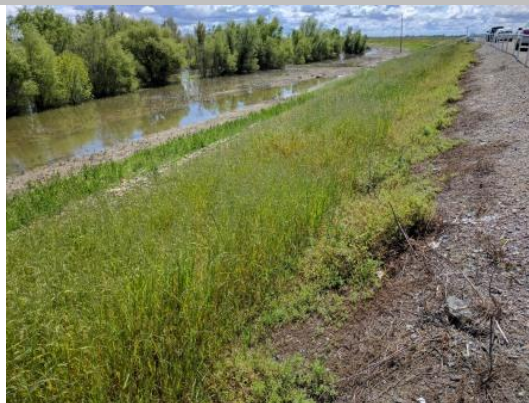
Photo 1 of 1 : SP_2017_ST0011_294_33_20170419_00025.jpg

View of tall grass on waterside levee slope, blocking visibility. Spring 2017.

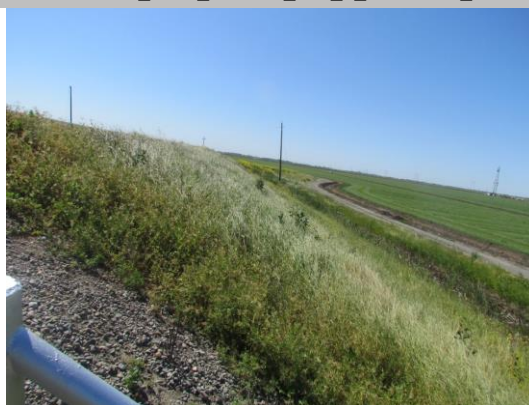
Photo 1 of 1 : SP_2017_ST0011_294_6_20170320_00007.jpg

View of the ditch on the landward side of the levee looking downstream. Spring 2015.

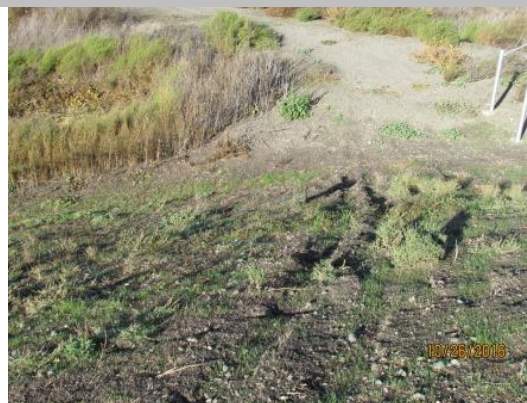
Photo 1 of 1 : SP_2017_ST0011_294_16_20170320_00009.jpg

Slope was damaged by vehicle. Fall 2016.

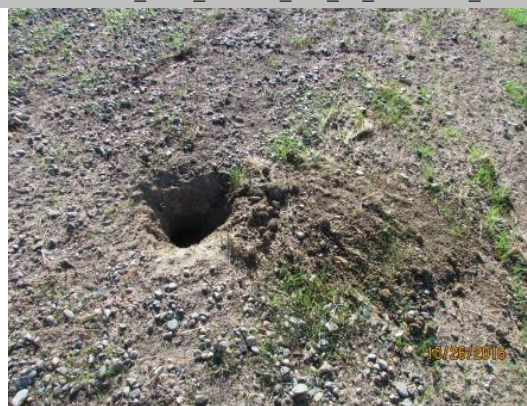
Photo 1 of 1 : SP_2017_ST0011_294_21_20170320_00015.jpg

View of an animal burrow. Fall 2016.

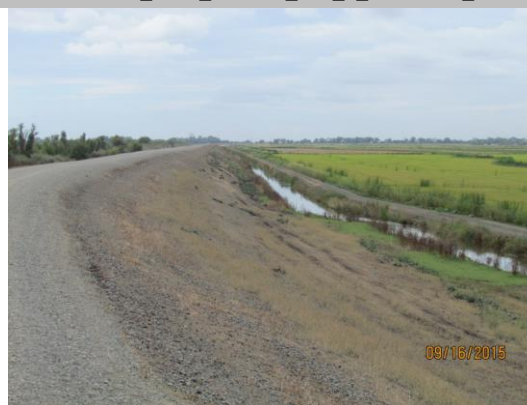
Photo 1 of 1 : SP_2017_ST0011_294_3_20170320_00004.jpg

View of the ditch along the levee toe on the landward side of the levee looking downstream. Fall 2015.

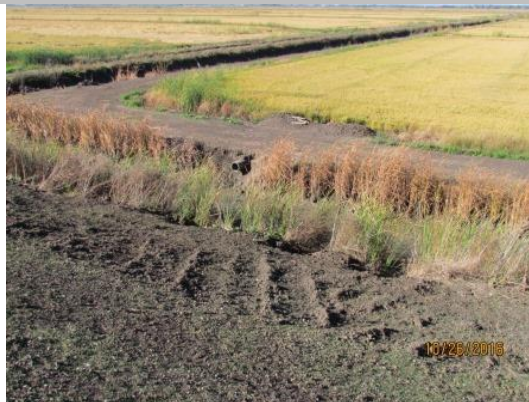
Photo 1 of 2 : SP_2017_ST0011_294_19_20170320_00013.jpg

View of erosion on landside levee slope. Fall 2016.

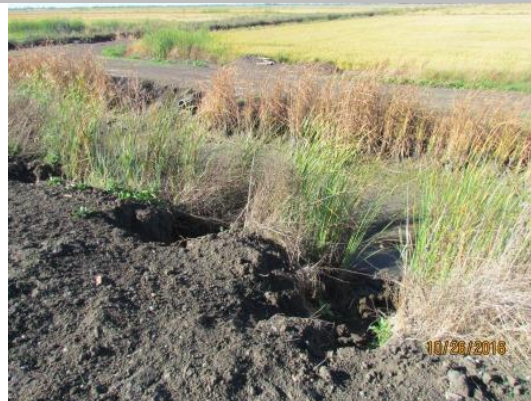
Photo 2 of 2 : SP_2017_ST0011_294_19_20170320_00014.jpg

Closer view of erosion. Fall 2016.

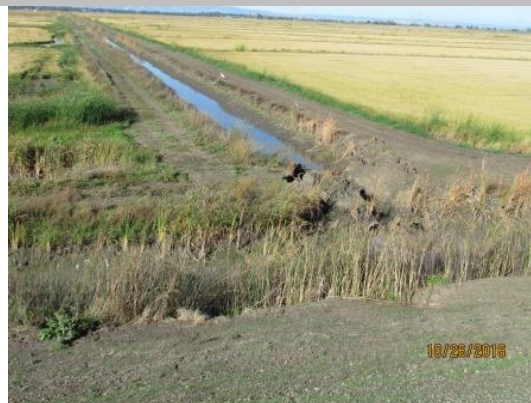
Photo 1 of 2 : SP_2017_ST0011_294_17_20170320_00010.jpg

View of erosion at landside levee toe. Fall 2016.

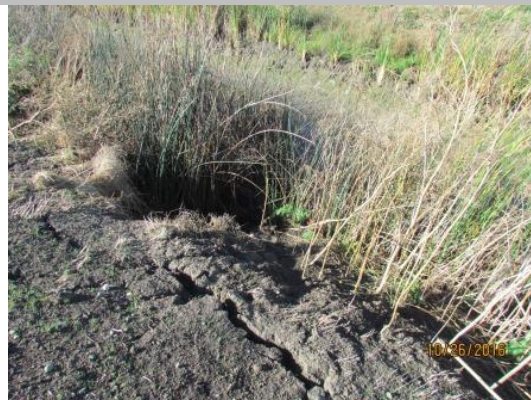
Photo 2 of 2 : SP_2017_ST0011_294_17_20170320_00011.jpg

Closer view of erosion. Fall 2016.

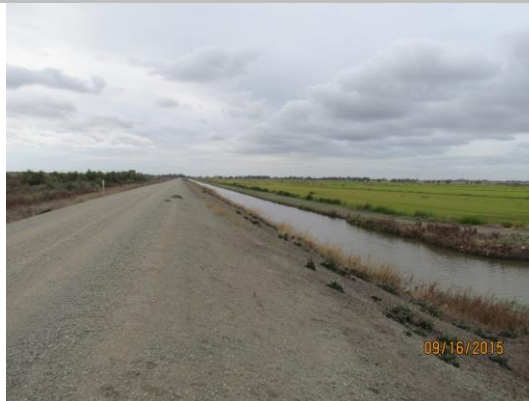
Photo 1 of 2 : SP_2017_ST0011_294_4_20170320_00005.jpg

The ditch is at the levee toe on the landward side of the levee looking downstream. Fall 2015.

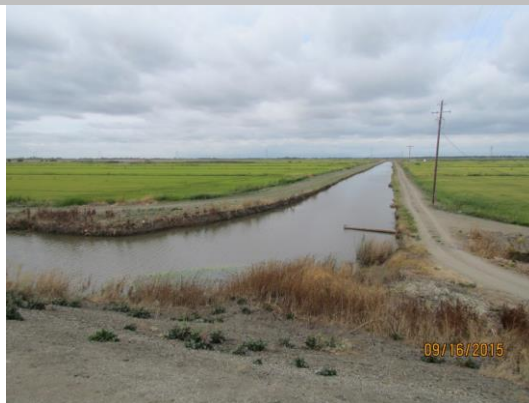
Photo 2 of 2 : SP_2017_ST0011_294_4_20170320_00006.jpg

Looking west at the agricultural ditch. Fall 2015.
